# Manhole Inspection Summary

Manhole # S33A\_\_026MH

Insp Date: **8/18/09 11:09 AM**

**Location** Address: **515 CENTRE ST** Cross Street: **CATHEDRAL ST**

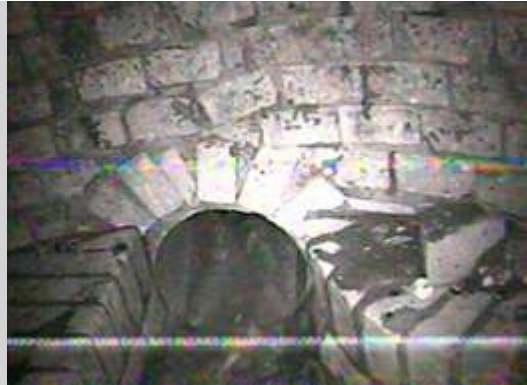
12 O'Clock Outflow

15 in. Circular Gravity Sewer  
Pipe Out @ 12 O'Clock

Pipe Height: (in.) Direct  
Pipe Material: **Clay** ☐ Pipe Lined  
Invert Depth: **17.93** (ft.) Flow Characteristics: **Fast**  
Deposits: ☒ None ☐ Mud ☐ Sludge ☐ Debris ☐ Grease  
Silt Depth: (in.) Deposits Extent:  
Infiltration: **None** Pipe Seal Cond: **Sound**

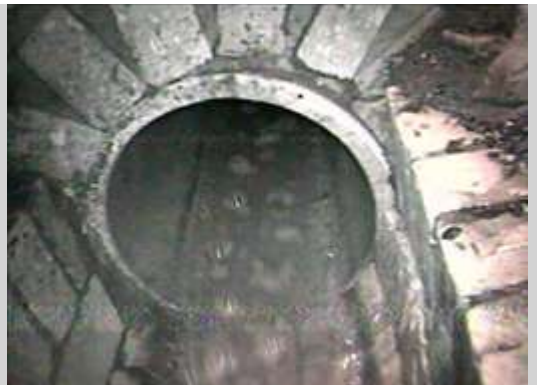
4 O'Clock Inflow

15 in. Circular Gravity Sewer  
Pipe In @ 4 O'Clock

Pipe Height: **15.6** (in.) Direct (Angled)  
Pipe Material: **Clay** ☐ Pipe Lined  
Invert Depth: **17.55** (ft.) Flow Characteristics: **Fast**  
Deposits: ☒ None ☐ Mud ☐ Sludge ☐ Debris ☐ Grease  
Silt Depth: (in.) Deposits Extent:  
Infiltration: **None** Pipe Seal Cond: **Sound**
